# **B4-01-90**

**D2-CPB-09 / D2-CPC-19**

AREA **ENGINE** •  
BAY/COLUMN/ZONE **BLOCKS 1 / R4-Q5 / B4-01-90** •  
NETWORK OUTLET **D2-CPB-09 / D2-CPC-19** •

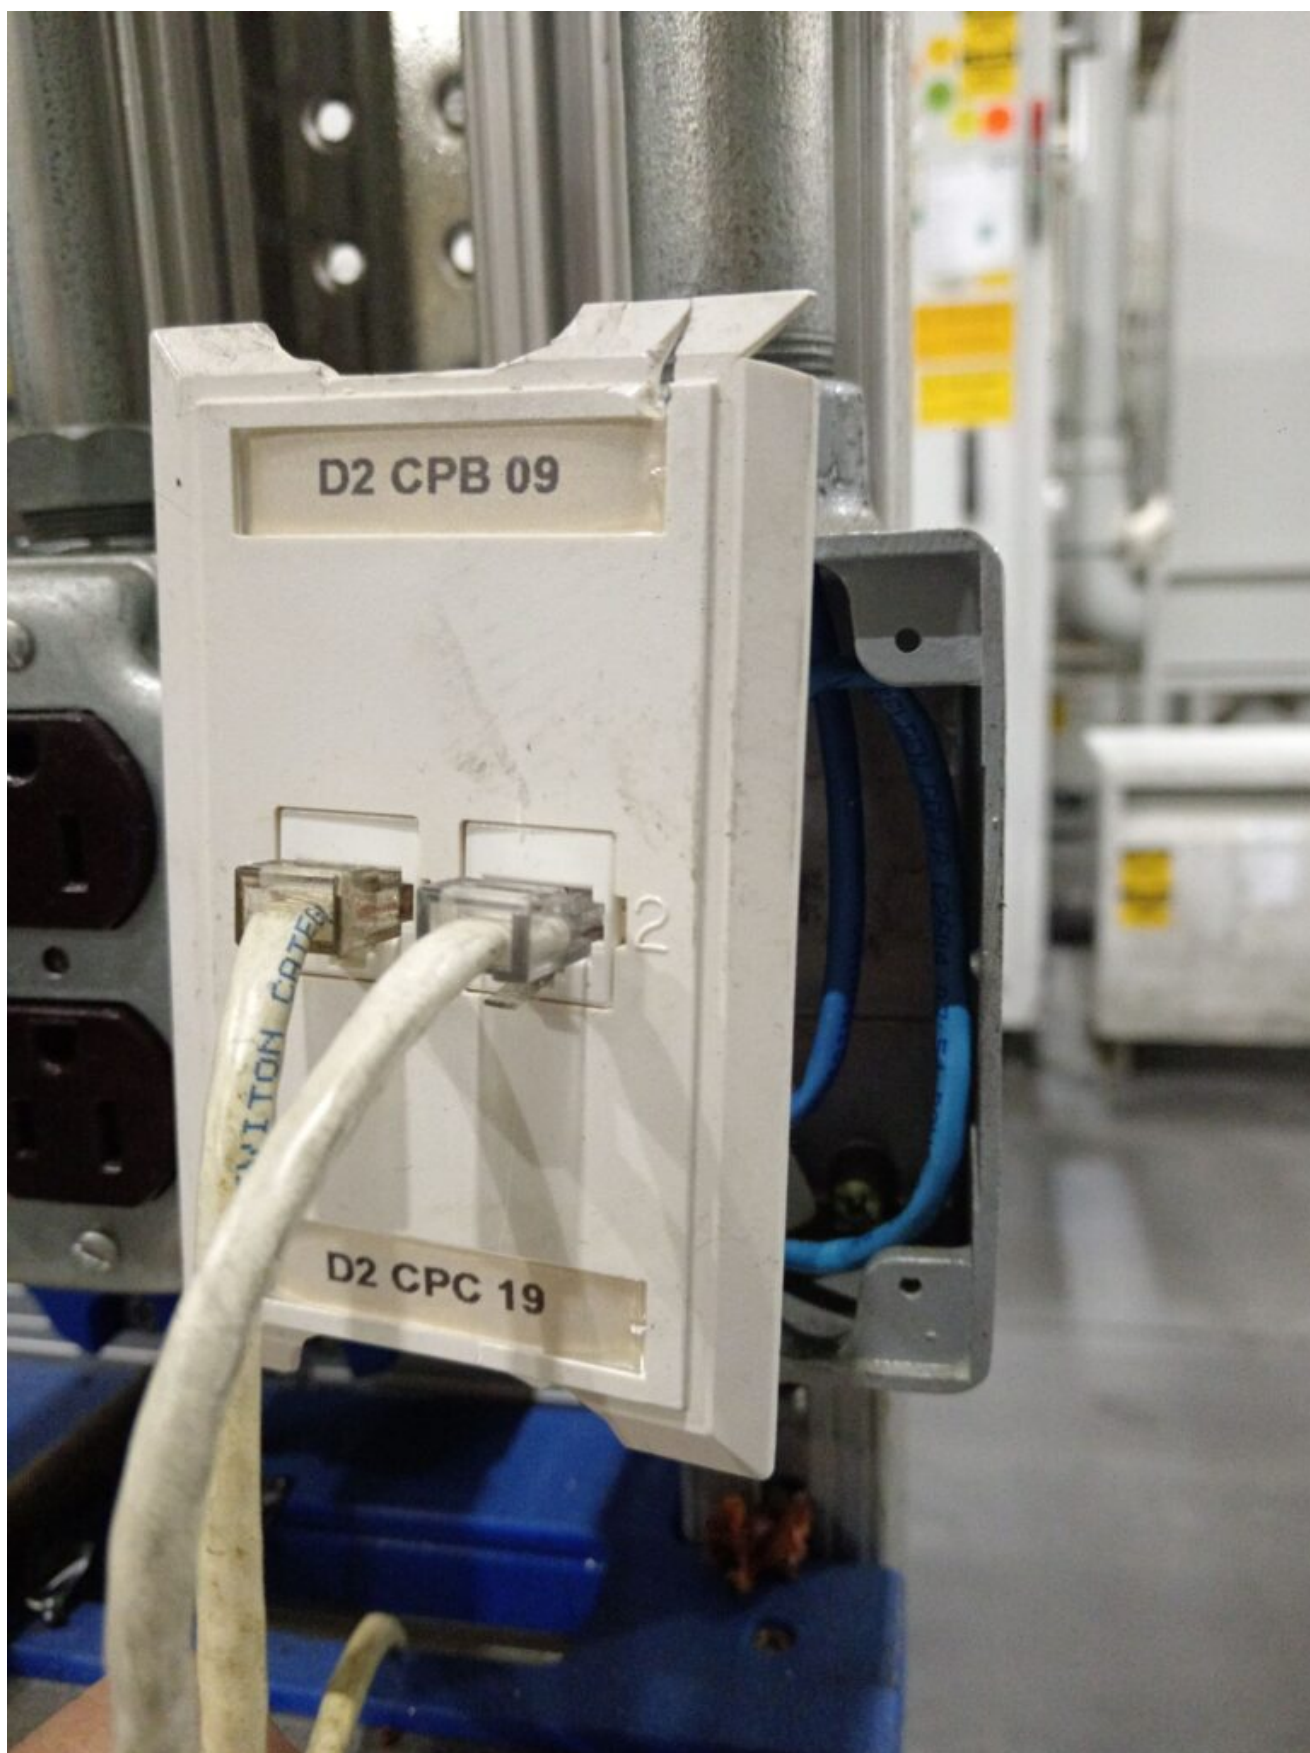
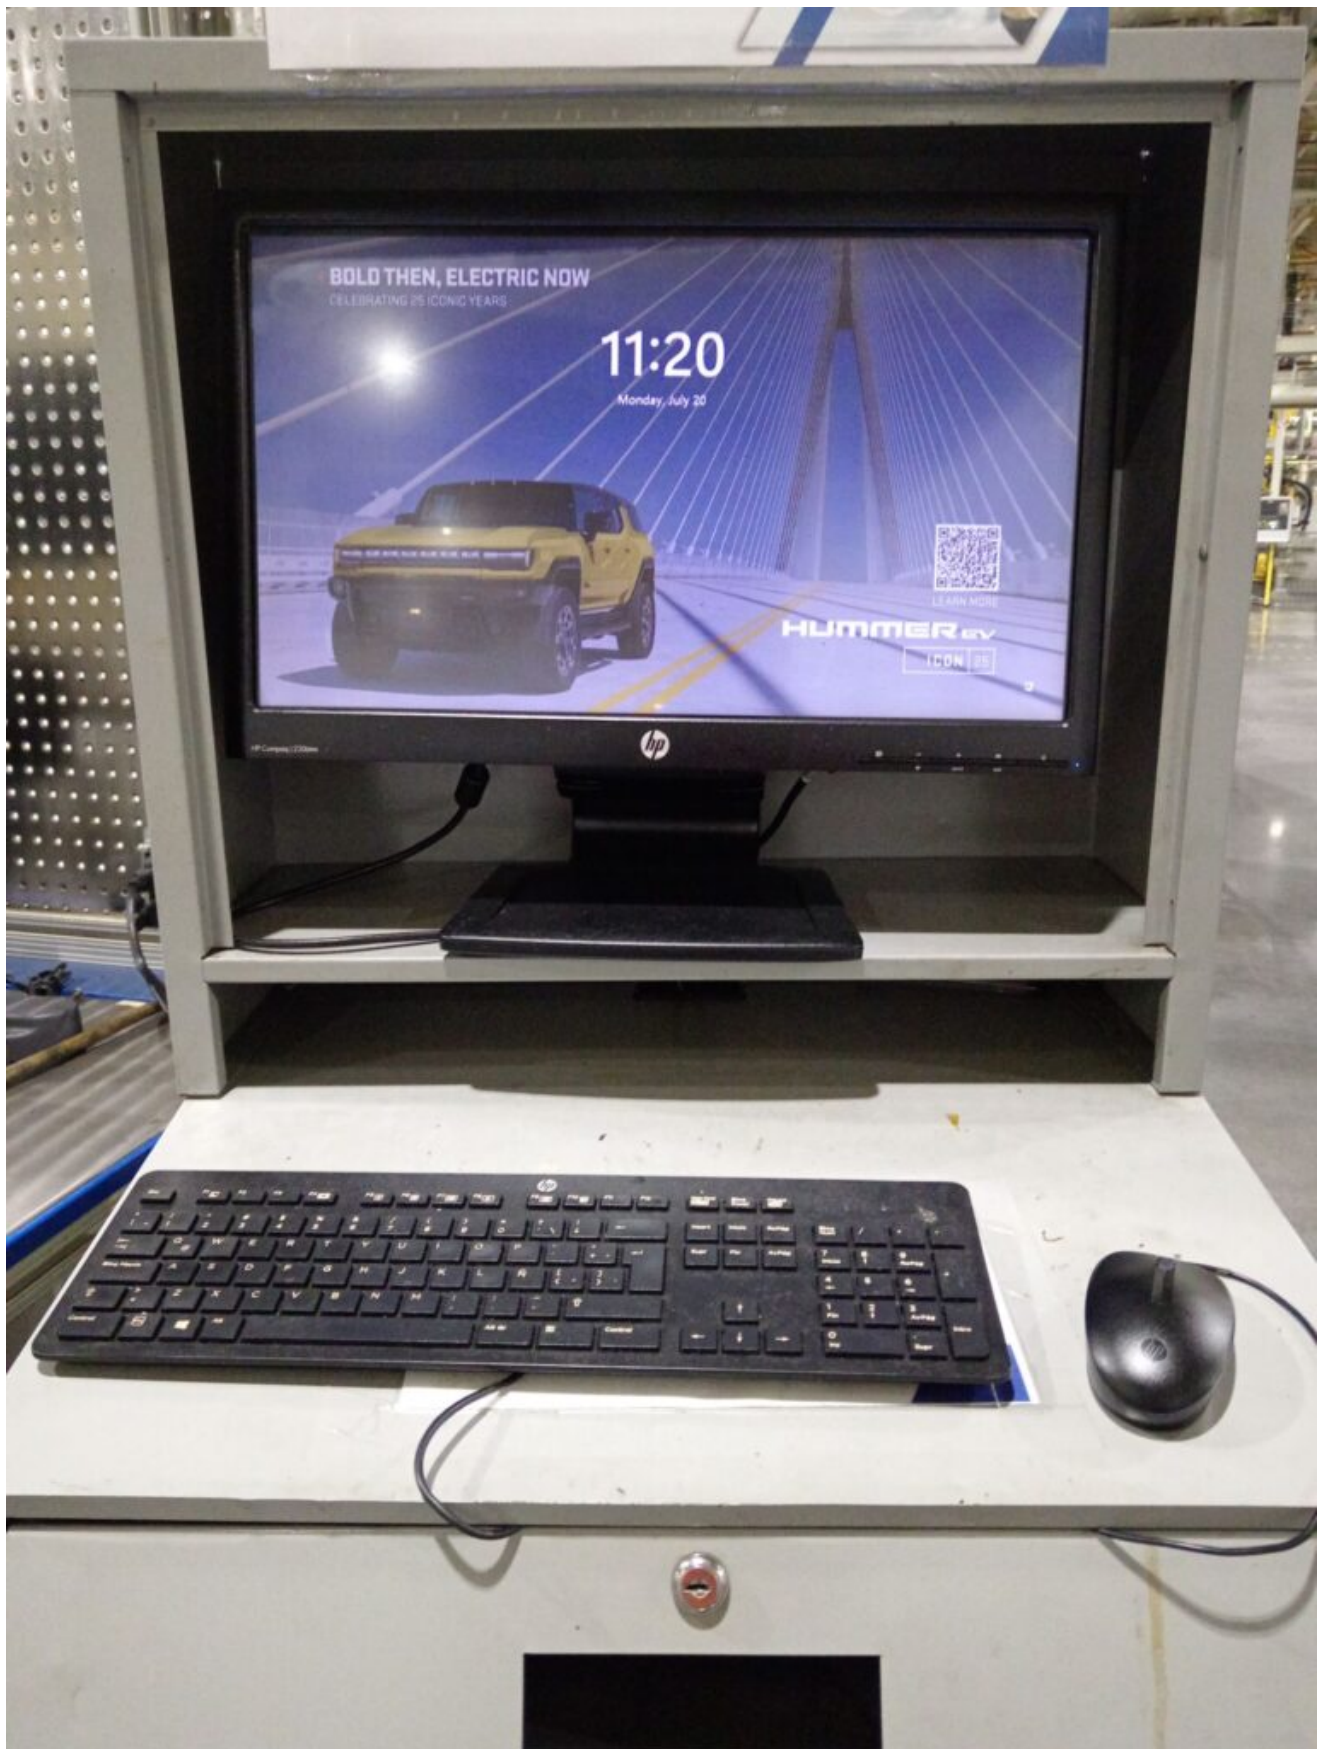
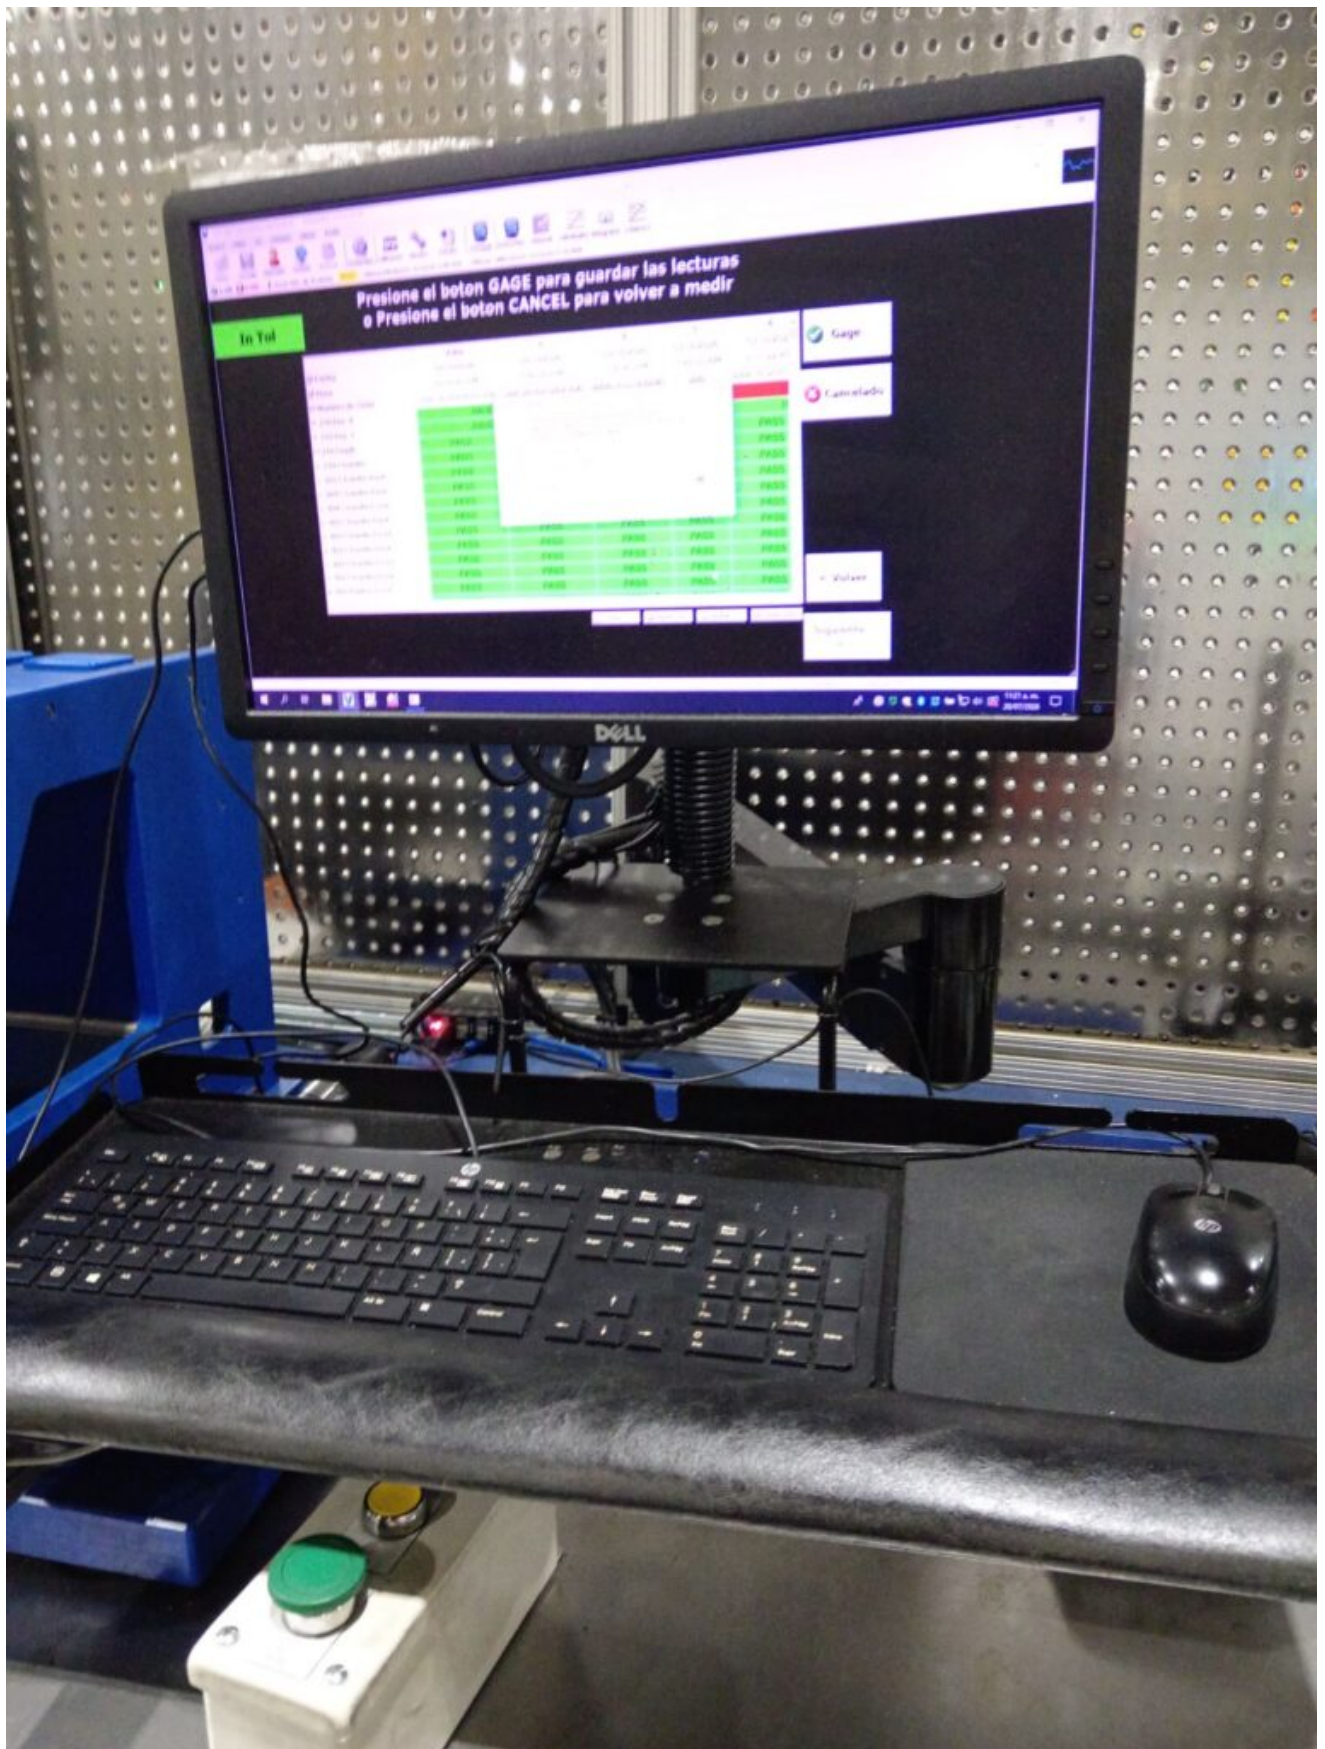
FACEPLATE 1 **DAMAGED / BROKE** •

RJ45 JACK A **FUNCTIONAL** •  
RJ45 PLUGS **DAMAGED / CLIP BROKEN** •  
CONNECTION **FIELD TERMINATED** •

RJ45 JACK B **FUNCTIONAL** •  
RJ45 PLUGS **FUNCTIONAL** •  
CONNECTION **FIELD TERMINATED** •
