# **B4-02-100-A**

**D5-CPA-15 / D5-CPB-21**

AREA **ENGINE** •  
BAY/COLUMN/ZONE **BLOCKS 2 / P5-Q5, B4-02-100-A** •  
NETWORK OUTLET **D5-CPA-15 / D5-CPB-21** •

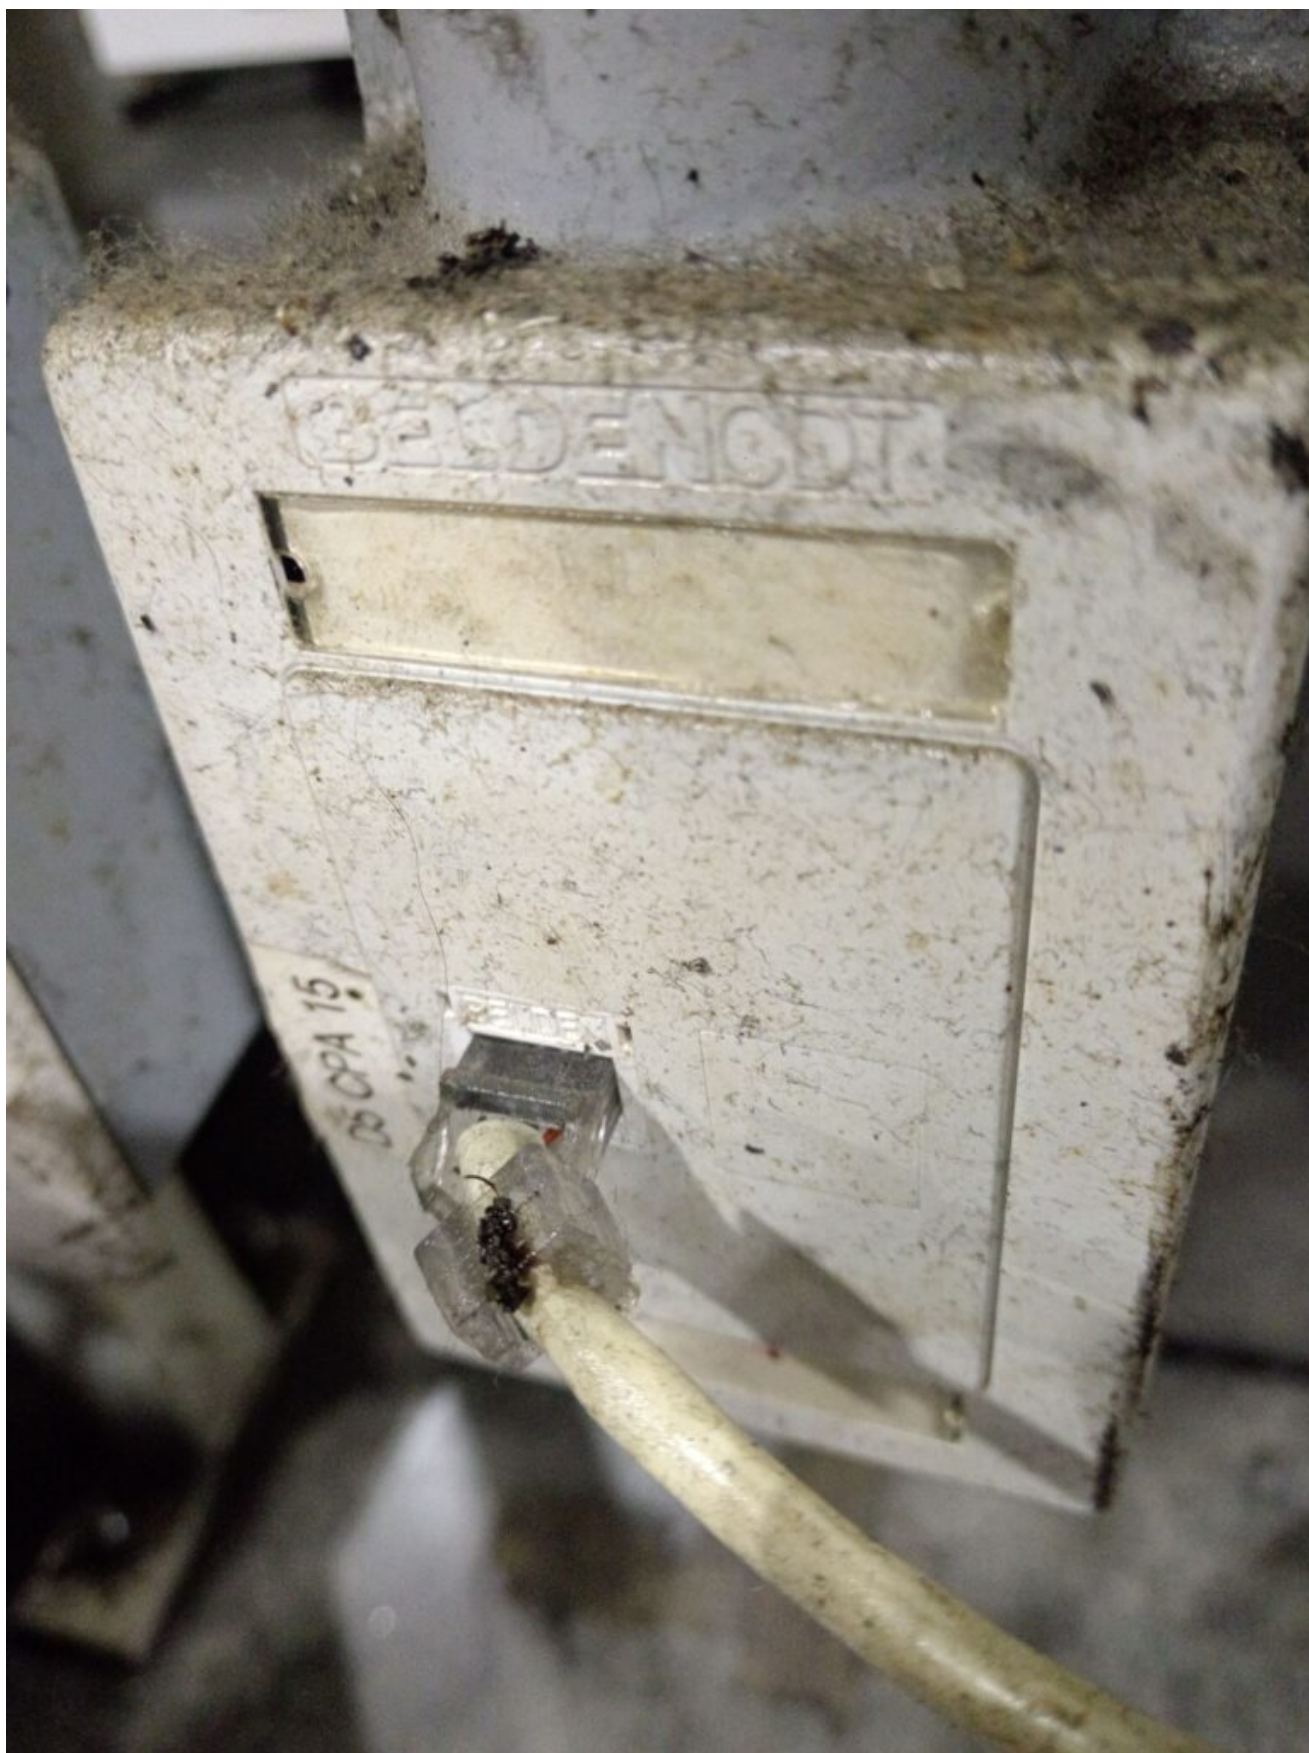
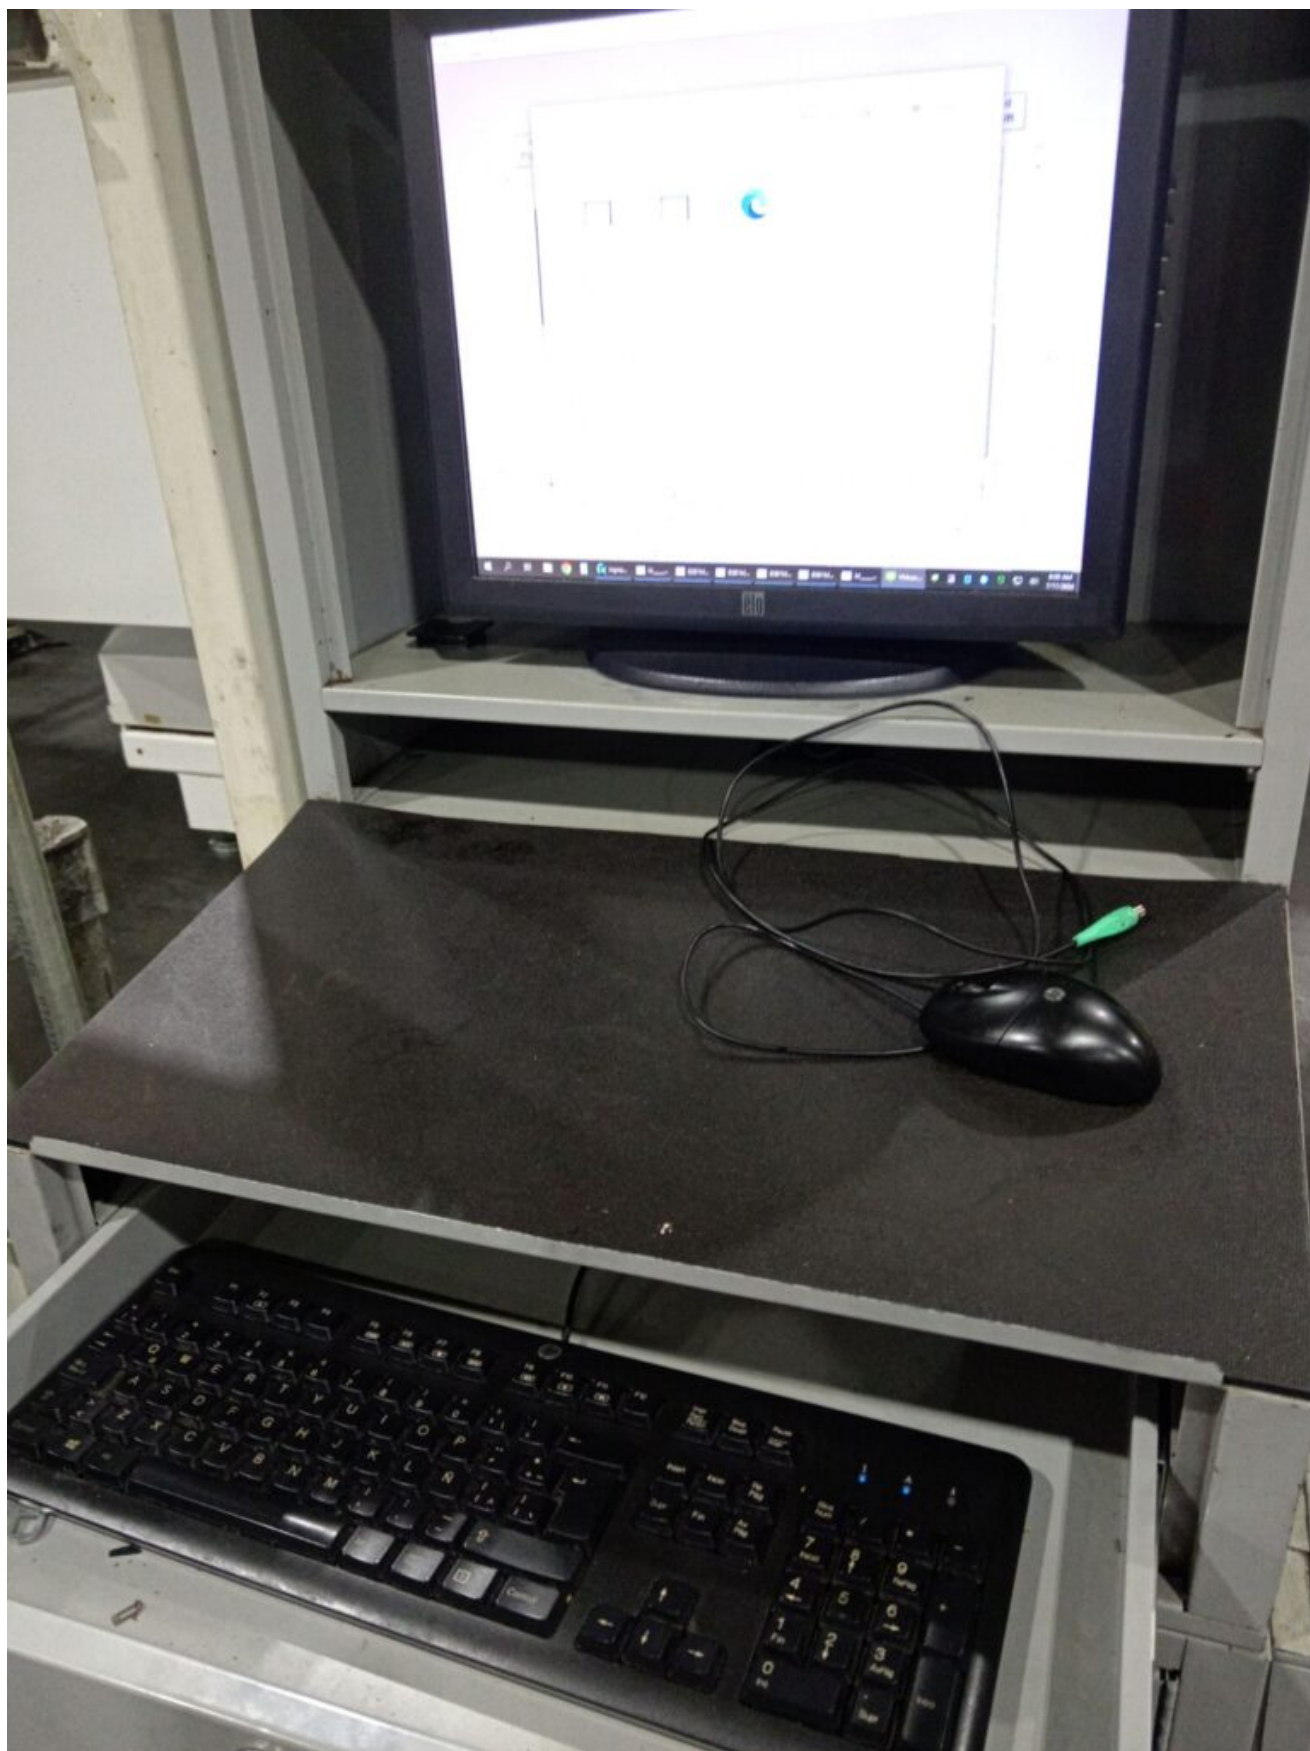
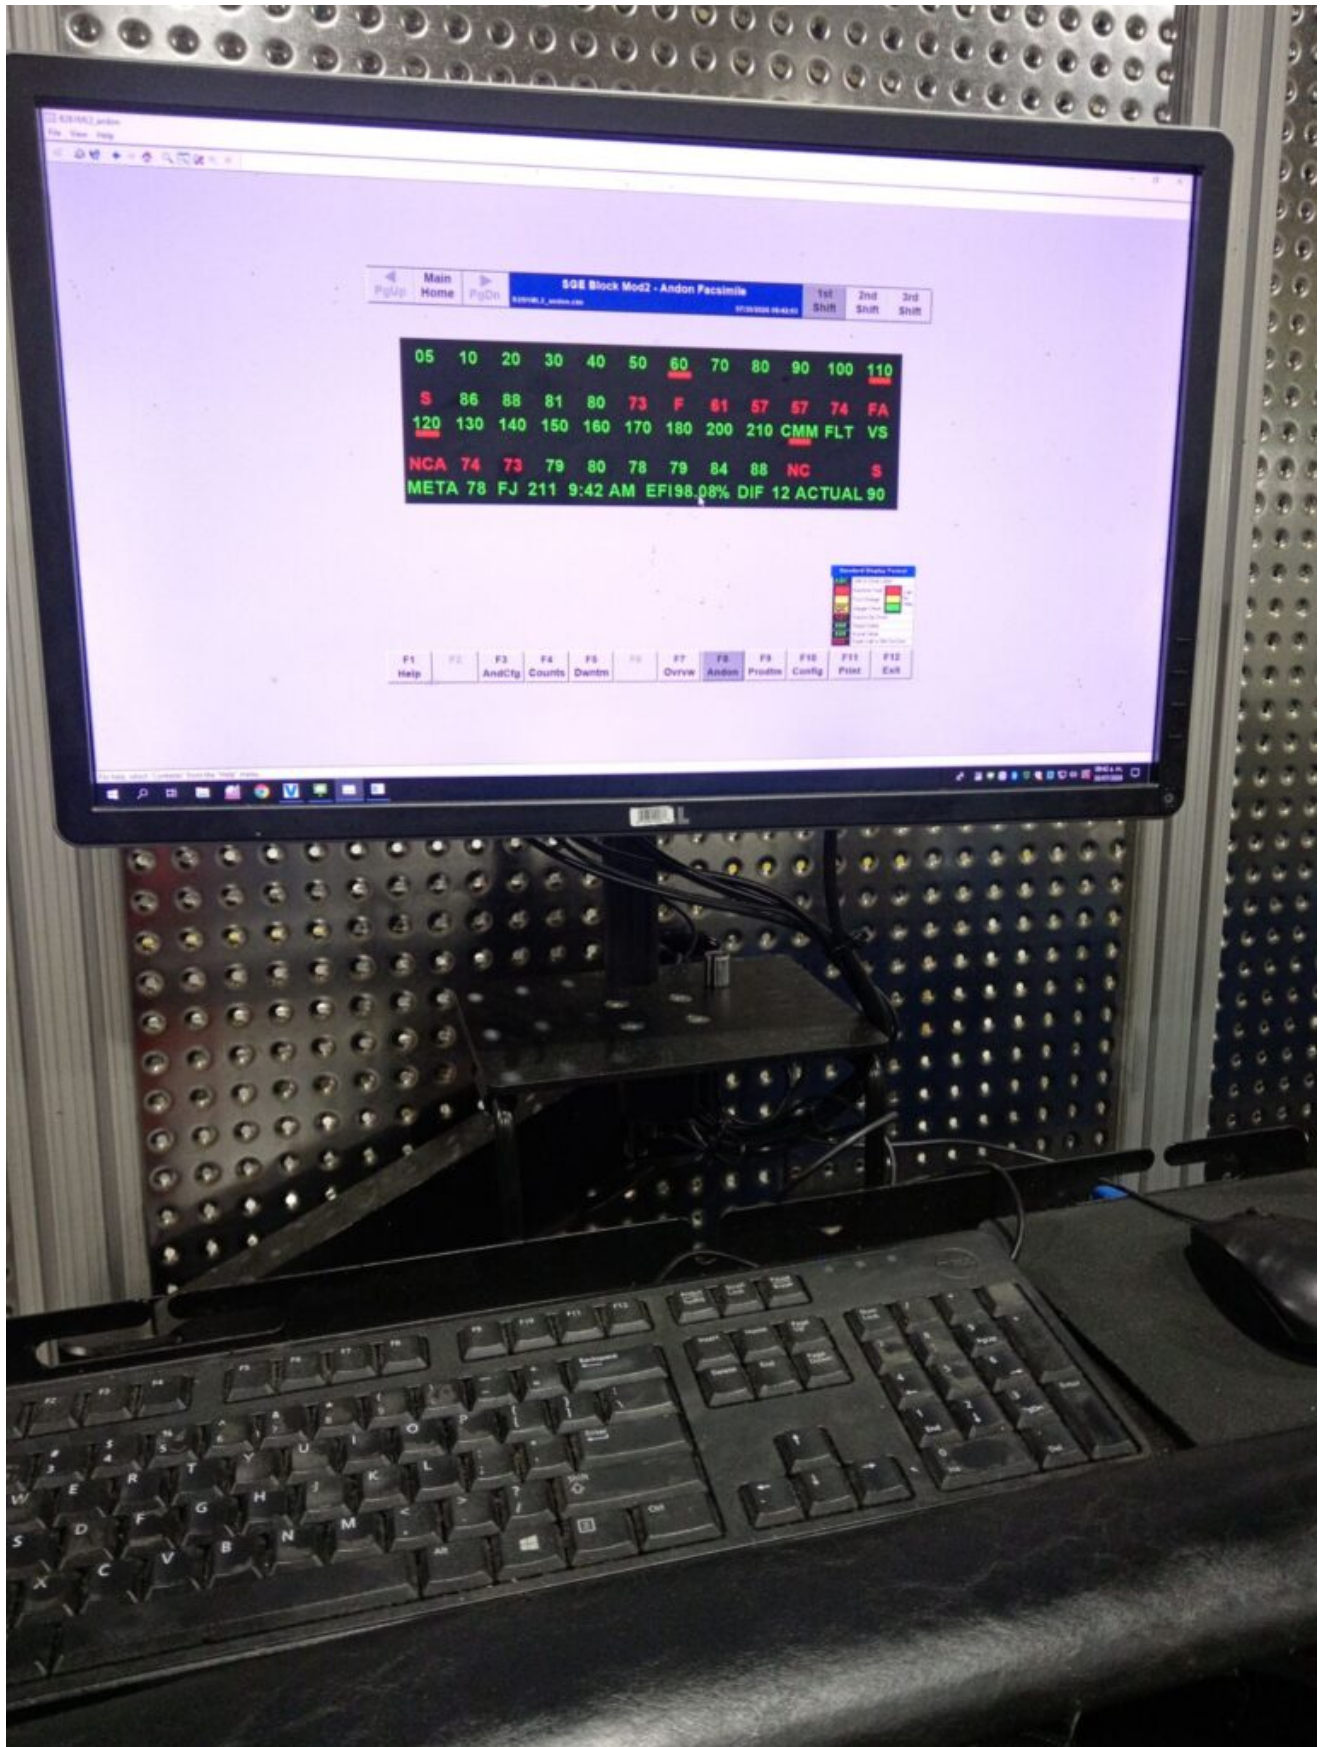
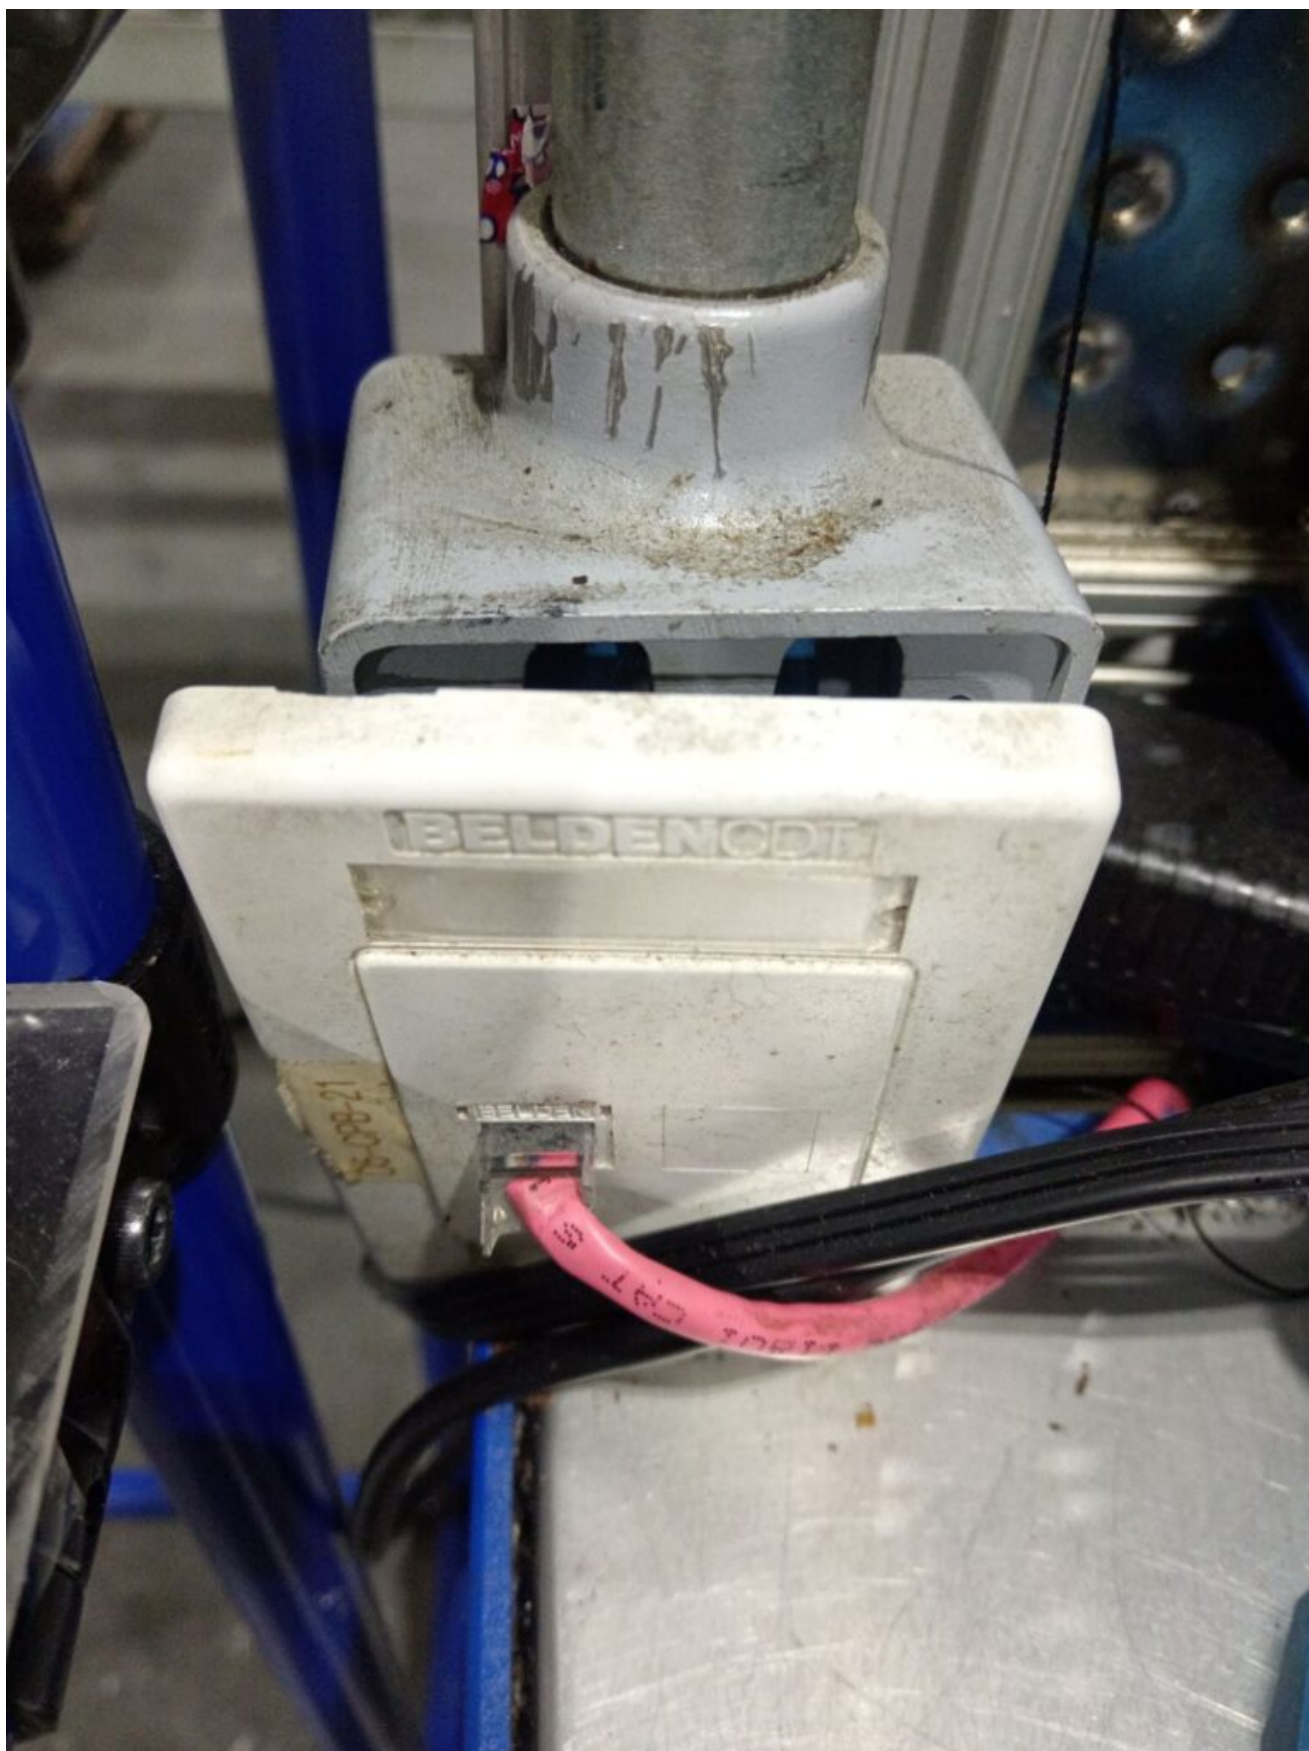
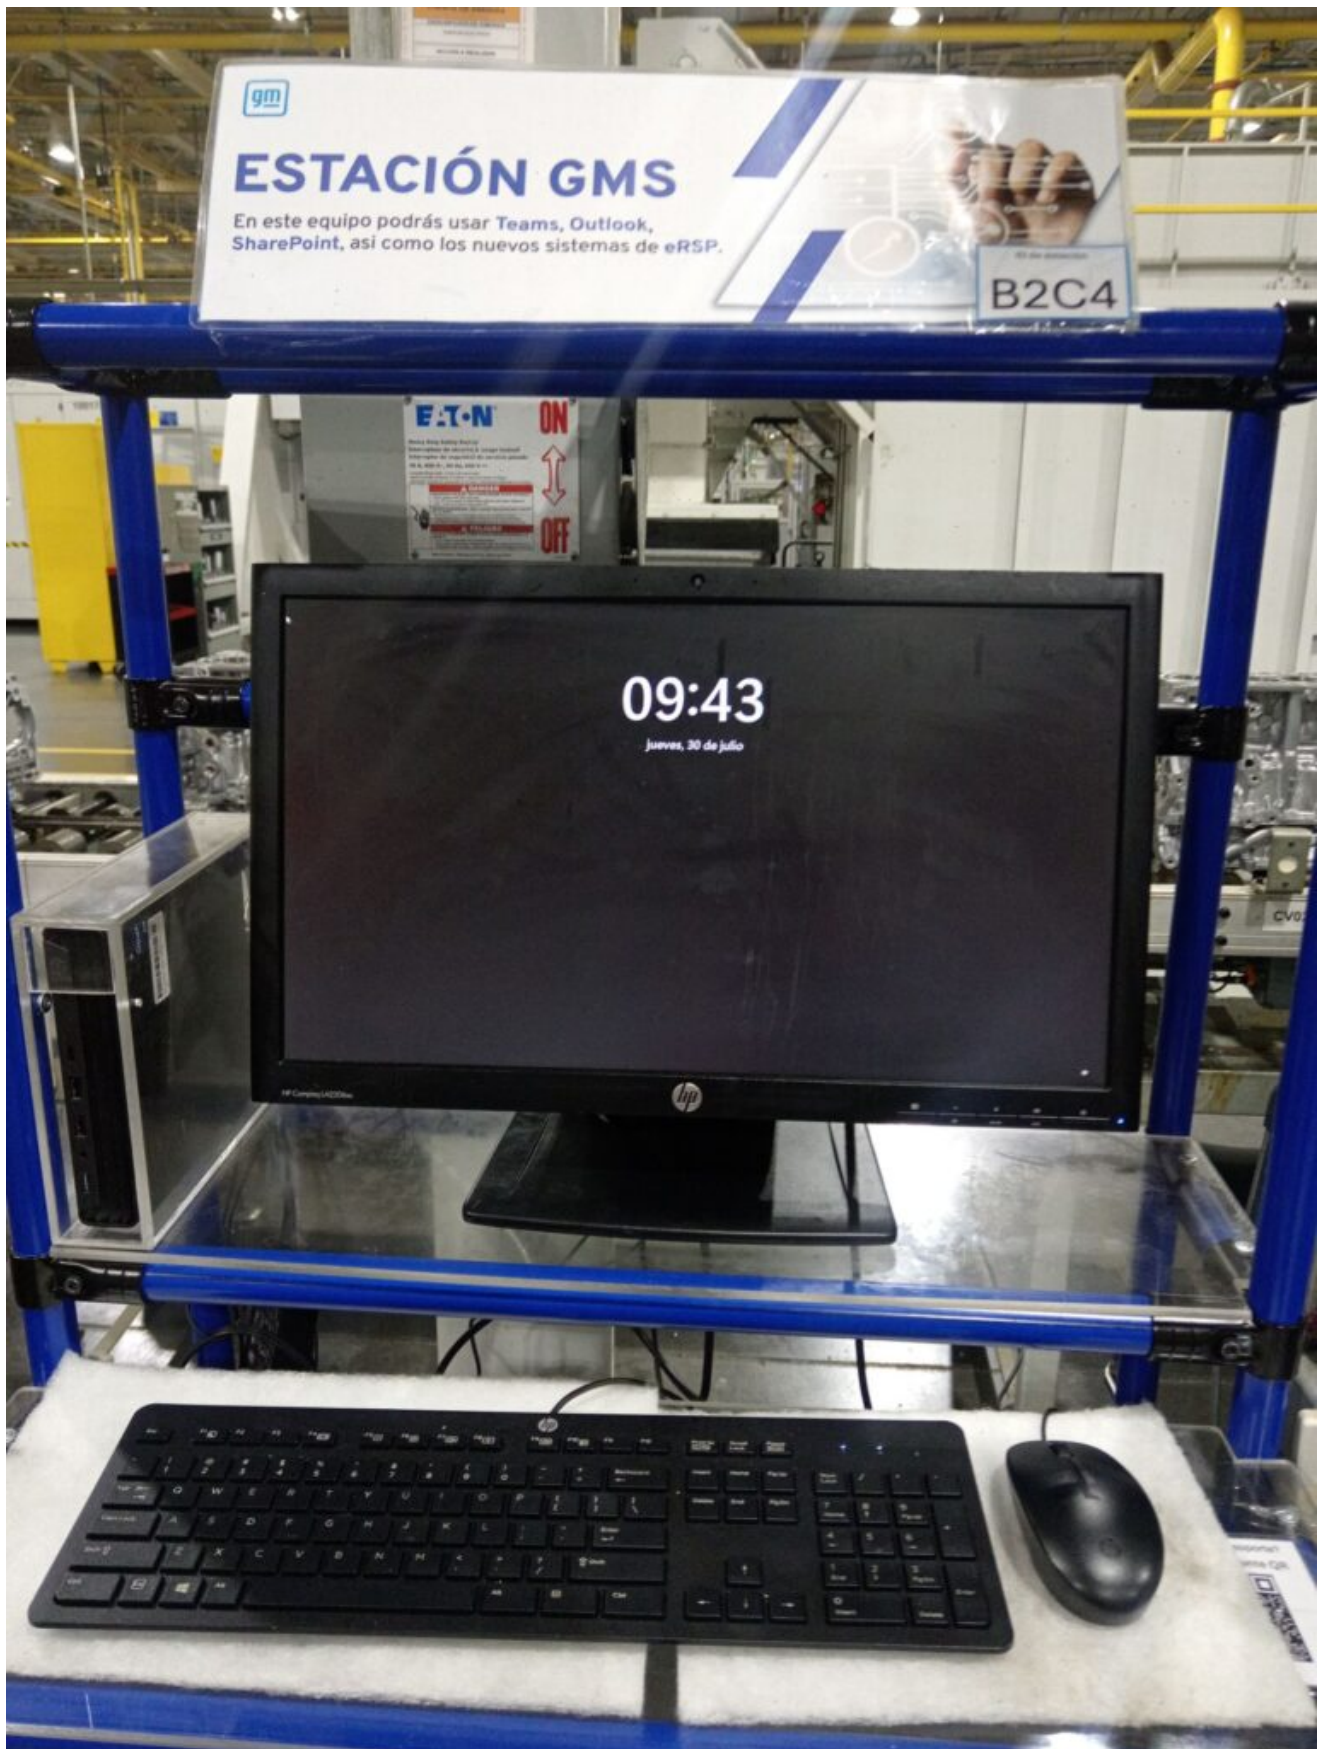
FACEPLATE 1 **YES** •  
FACEPLATE 2 **DAMAGED** •

RJ45 JACK A **FUNCTIONAL** •  
RJ45 PLUGS **DAMAGED / CLIP BROKEN** •  
CONNECTION **FIELD TERMINATED** •

CPU **YES / OPERATIONAL** •  
MONITOR **YES / OPERATIONAL** •  
KEYBOARD **YES / OPERATIONAL** •  
MOUSE **NO** •  
CONNECTION / **ETHERNET** •  
RECOMMENDED PATCHCORD LENGTH **1.5m** •

MOUSE **YES / OPERATIONAL** •  
CONNECTION / **ETHERNET** •  
RECOMMENDED PATCHCORD LENGTH **4.5m** •
